SITE INSPECTION NOTES

Church Name: St Tewdric's Church, Mathern

Project Ref: 23-1023

Date: 23rd June 2025

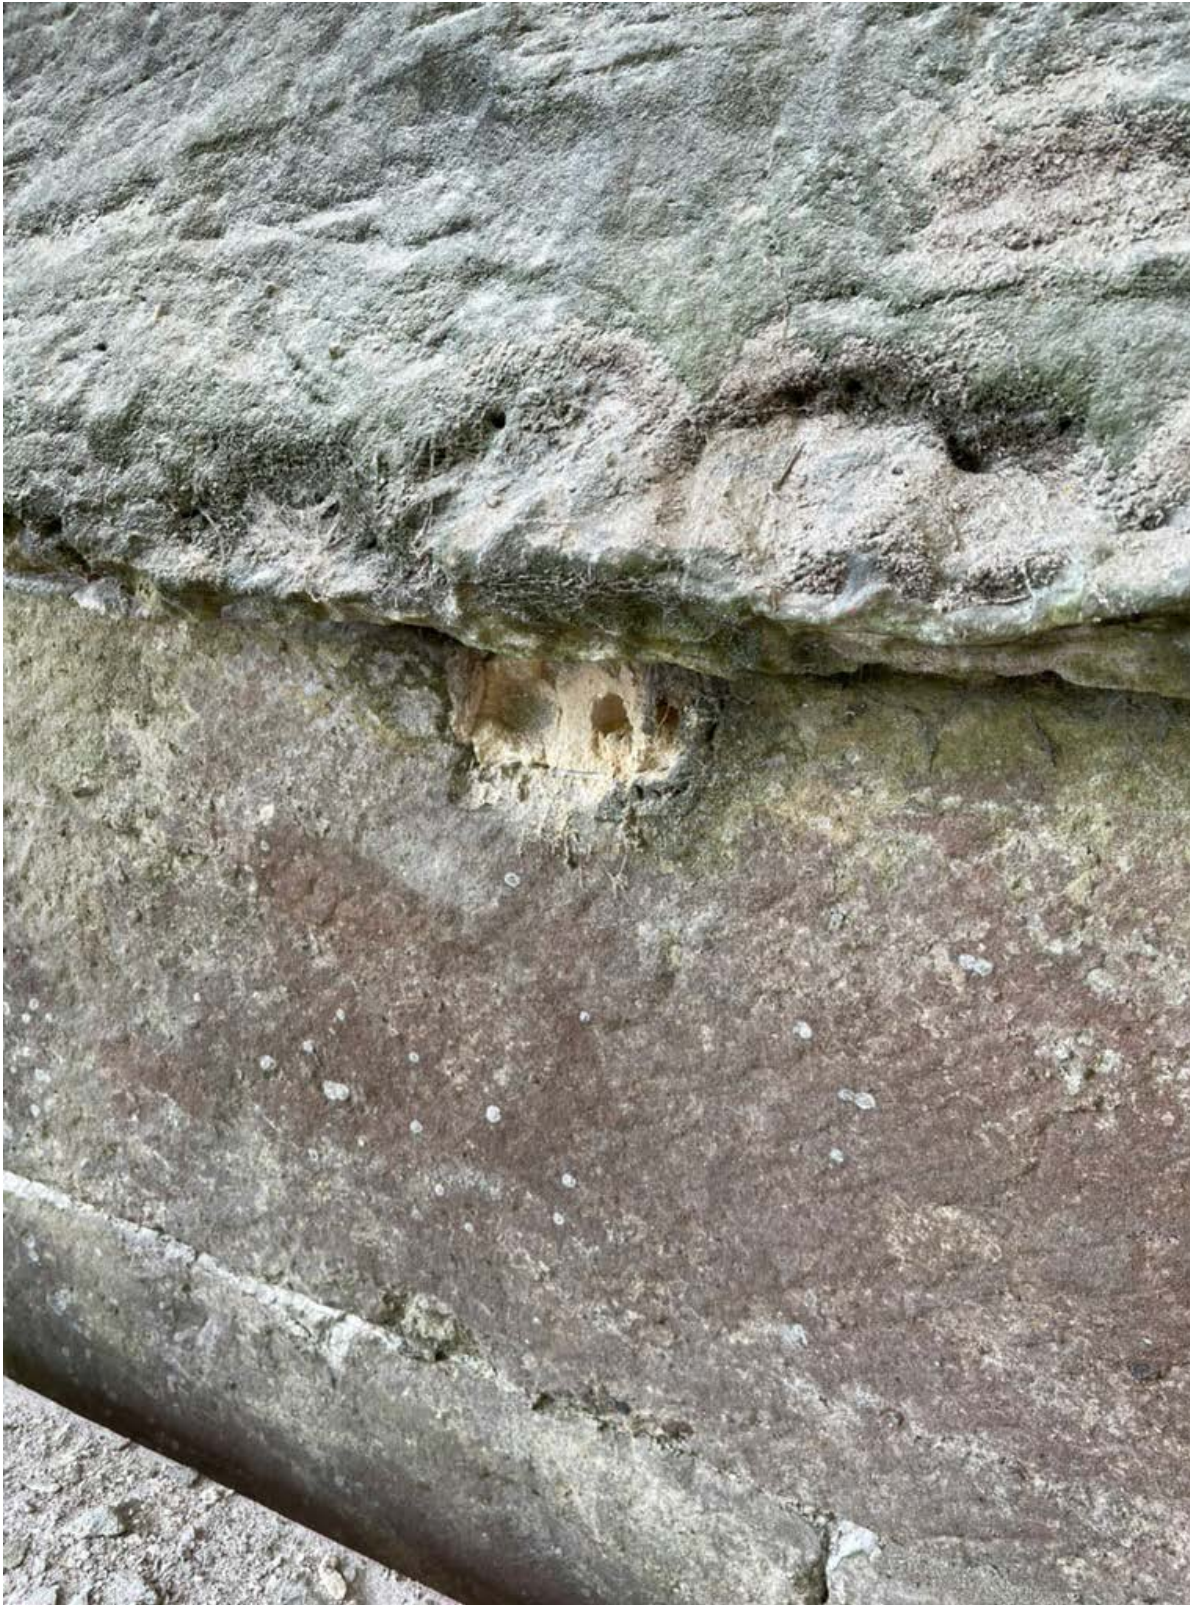
Image 1: North elevation of the tower to the sting course below the ringing chamber. A small stone indent is to be included on the list.

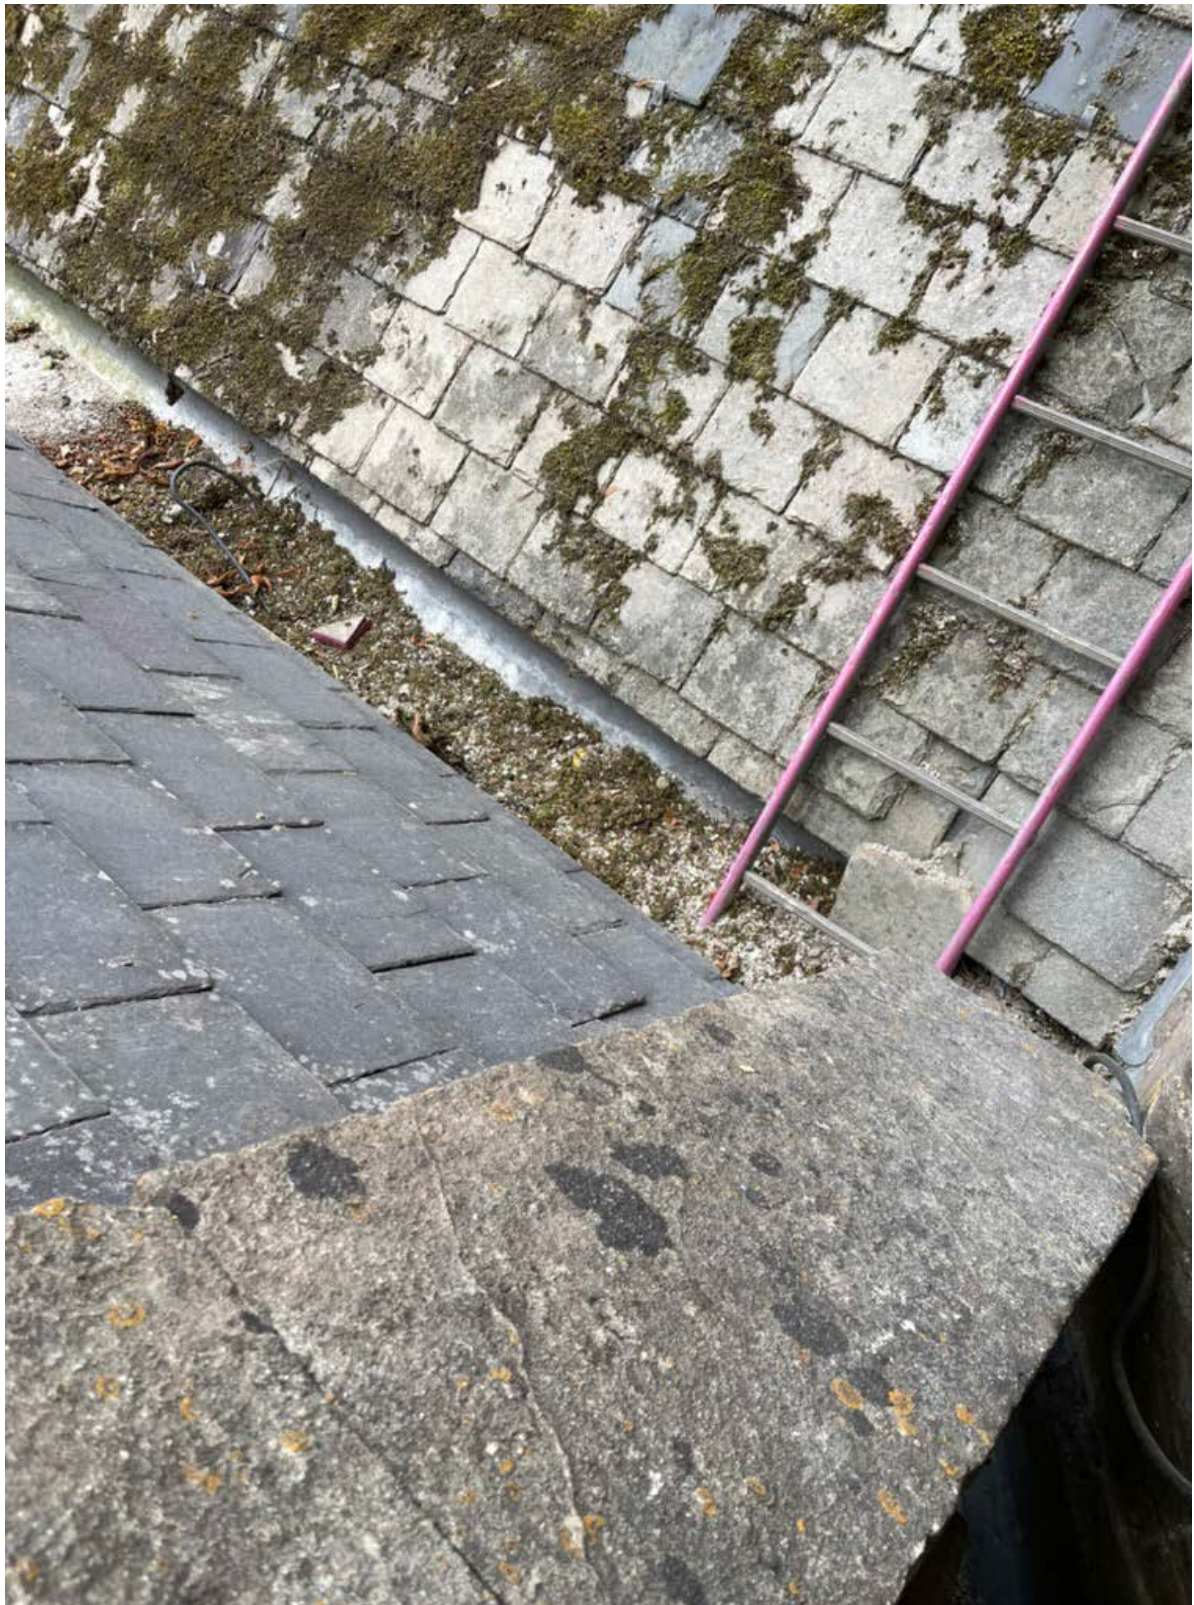
- 3.11. Conversation with Andrew regarding the timber flagpole beam are to be held so that an understanding of requirements can be obtained.
- 3.12. The lead box gutters are to be cleared in full, and assessment of their condition provided. It was noted that there was an active leak to the west of the north aisle gutter at the previous site visit. This area is to be inspected.

- 3.13. It was noted that the scaffolders had left their ladders leaning across the north pitch of the nave roof, resting in the box gutter. The ladders are to be removed.

- 3.14. There are several areas of the roof where slate repairs are required. These are to be quantified and confirmed to the architect.

Image 2: Scaffolding ladders have been left on the roof. Small number of slates to be repaired to this area, and to the wider roof (where access permits). Large amount of build-up of moss in the lead box gutters, this has formed a blanket towards the west discharge point. The lead is to be inspected once the materials have been removed.

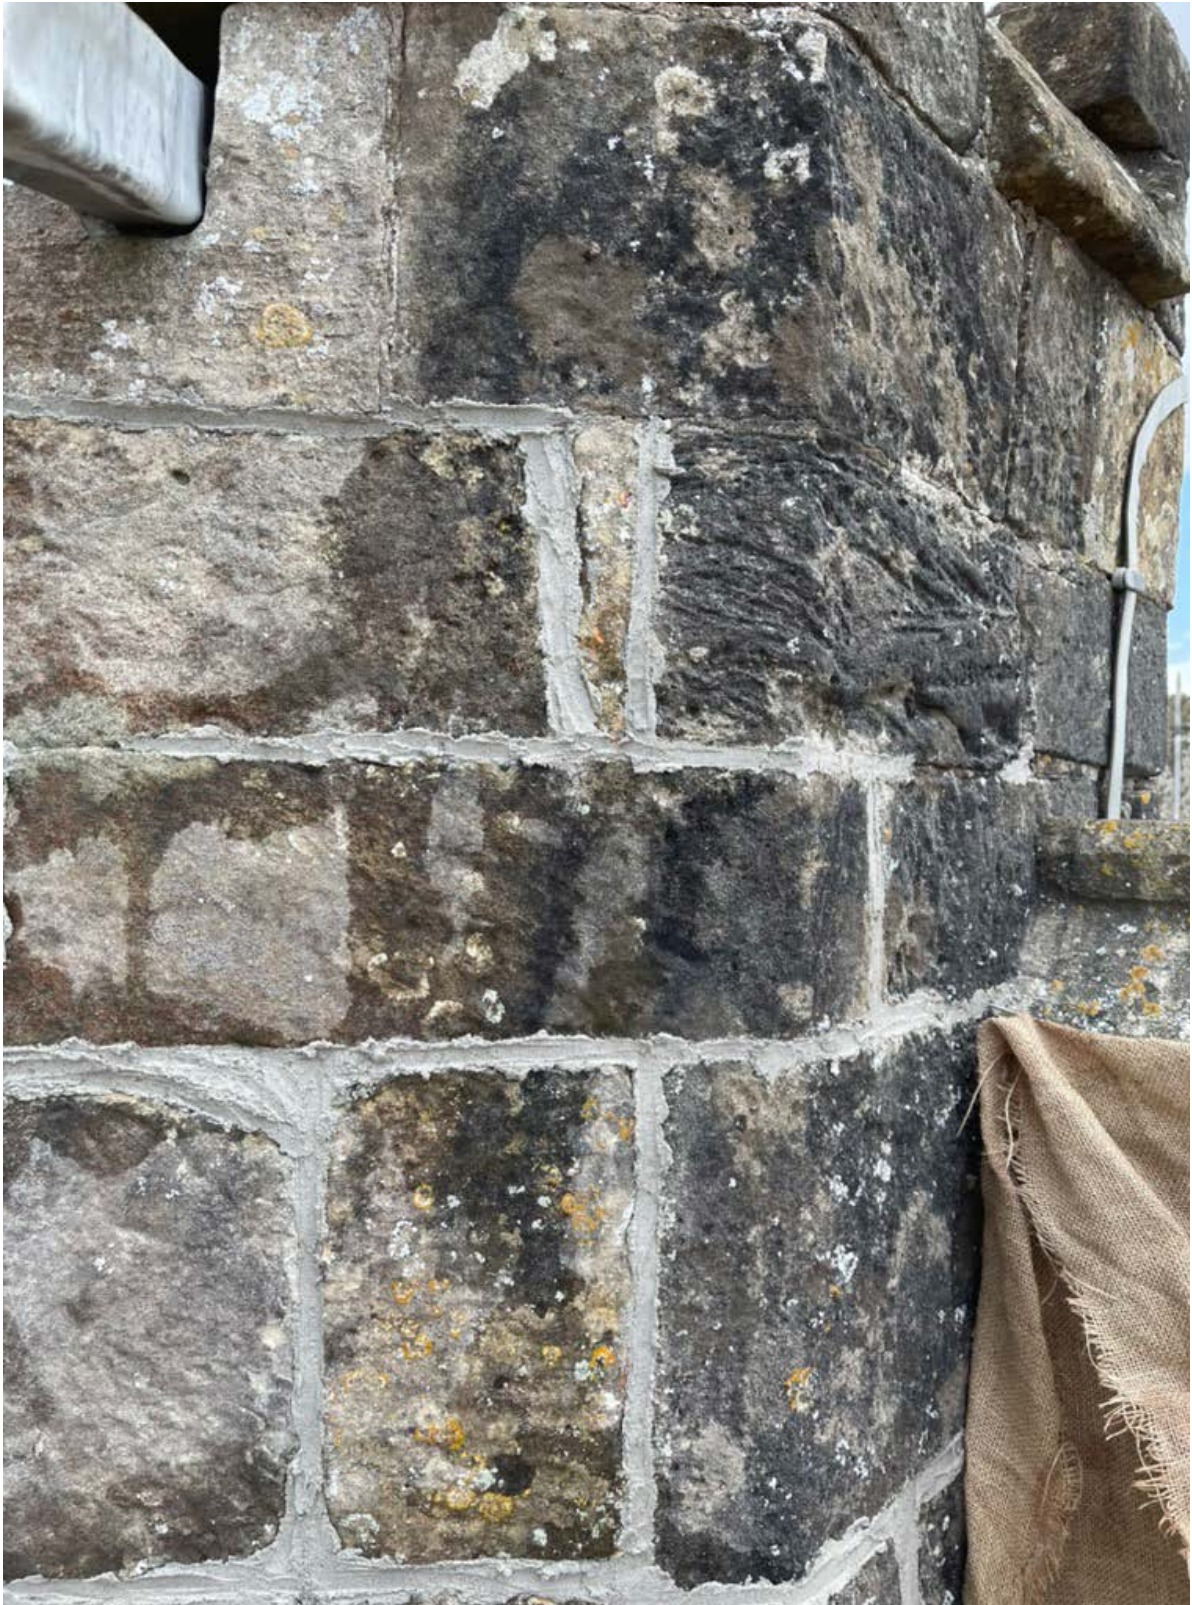
- 5.1. None to report. Application of lime mortar is in the initial phases. No tamping back as been carried out yet, this will start soon once the lime is ready.

Image 3: The process of lime mortar repointing requires the lime to be tended and is not a quick process and is influenced by the weather conditions. The image above provides an example of lime most recently applied within the joint. Once this is ready and 'leather-hard' it will be knocked-back/tamped with a churn brush to expose the aggregate. Please note, this is not the final finish!

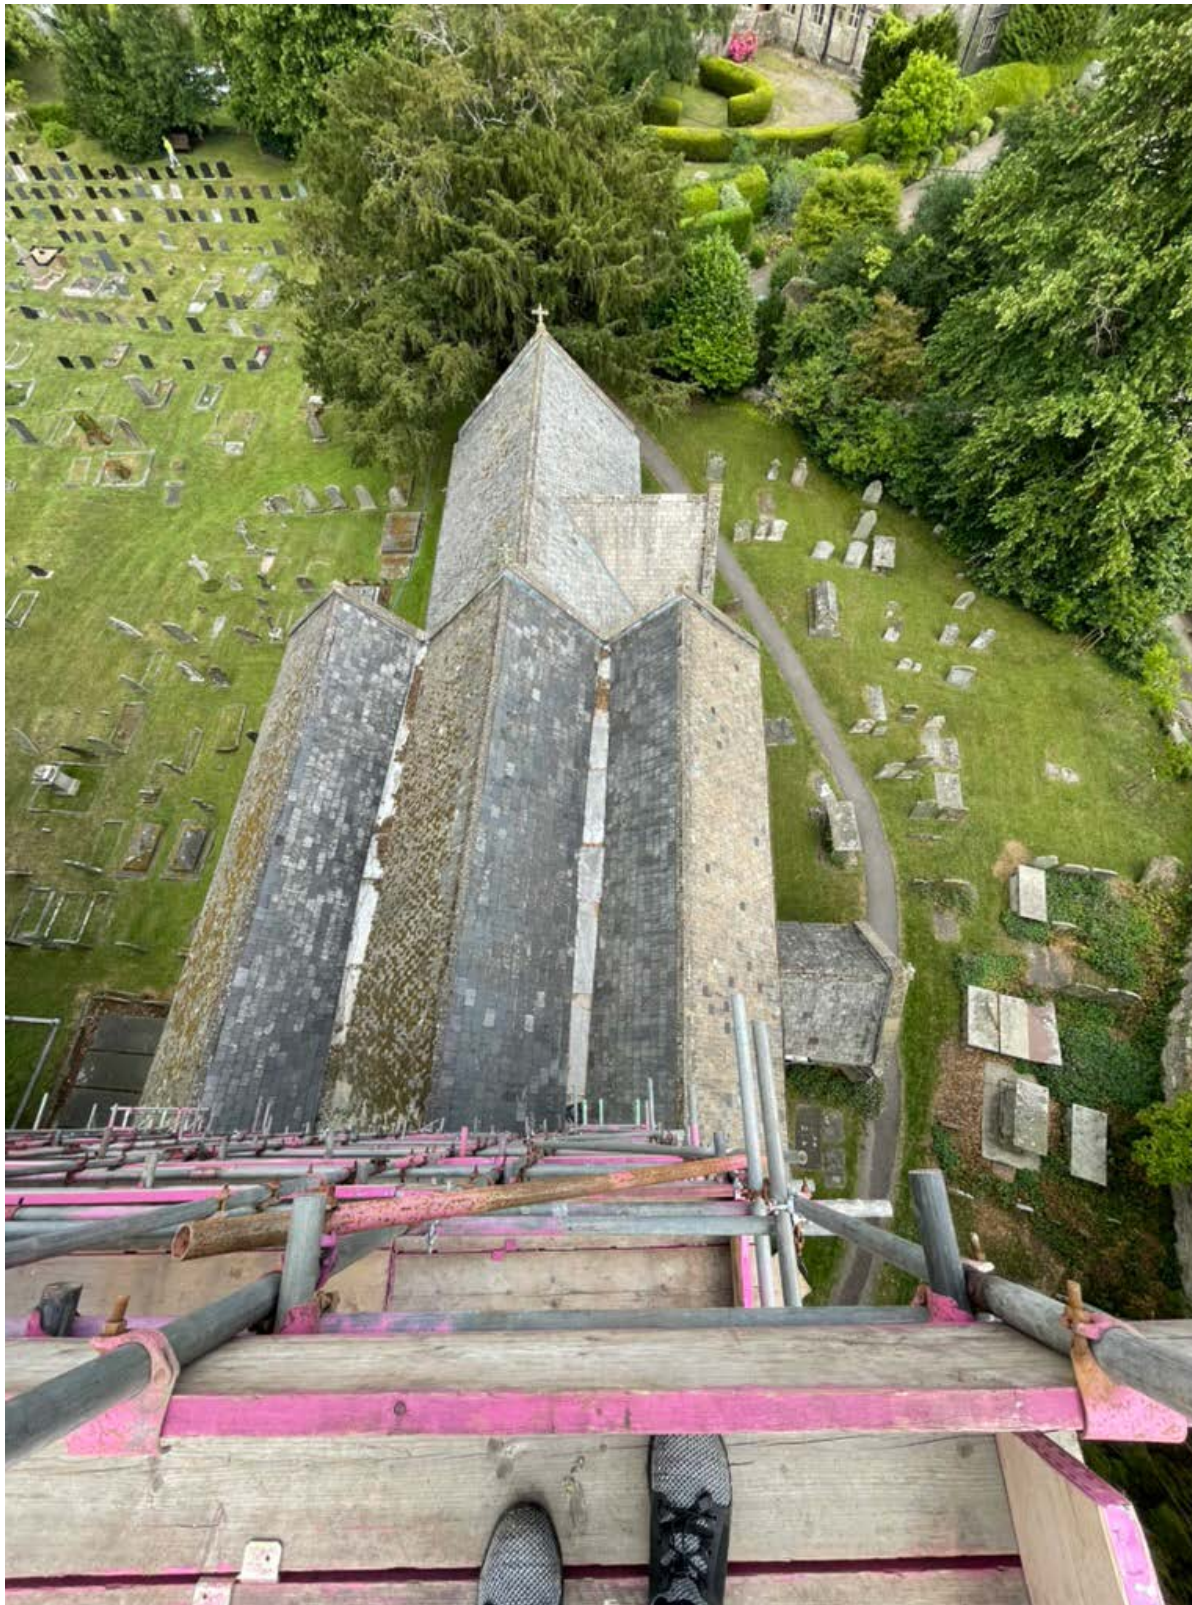
Image 4: View over the roof which illustrates the build-up of moss to the north pitches of the roof covering. Moss should ideally be removed to prevent the build-up falling into the lead box gutters, and ultimately the downpipe and below ground drainage systems. The lead box gutters are to be cleaned.

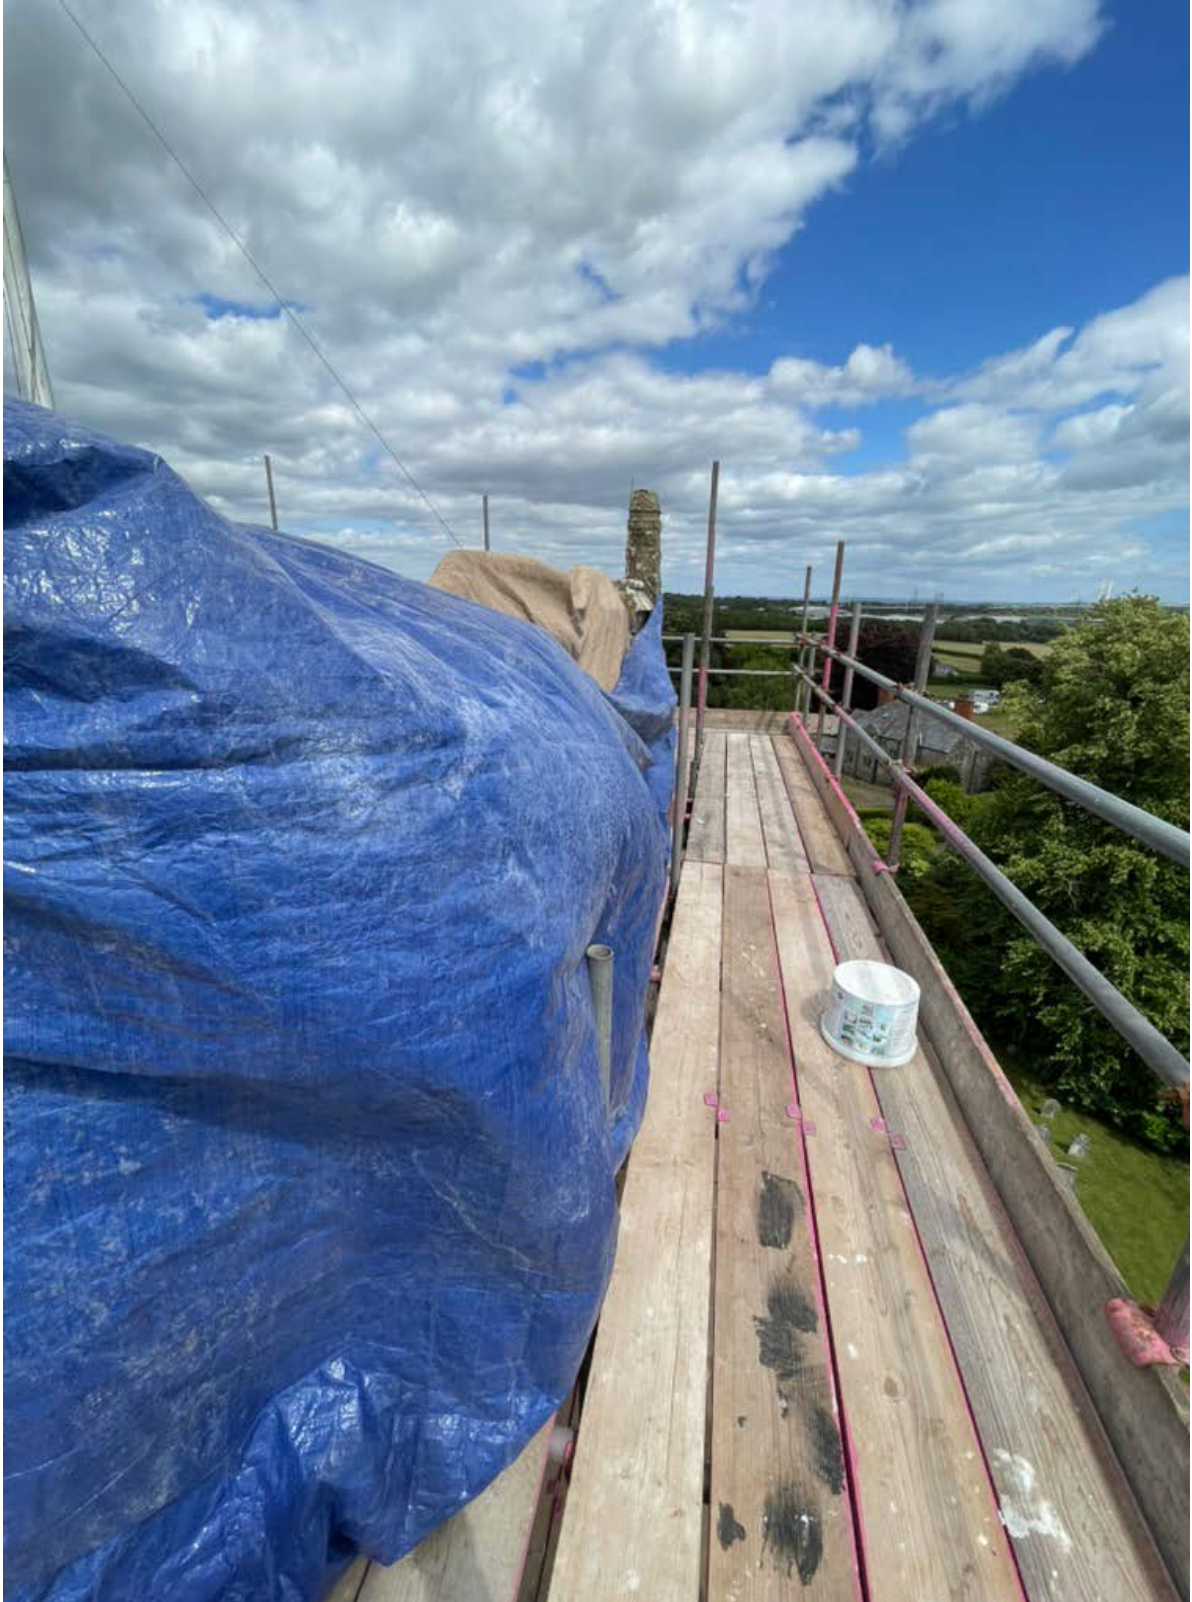
- 3.2. During the inspection wetting down of the lime was observed, along with protection added to prevent rapid drying from the sun.
- 3.3. The sections of wall to the vice which are accessible from the tower roof are to be de-pointed. The merlons and crenels to the top of the vice are also to be inspected.

Image 5: Protection with hessian and tarpaulin to the south wall of the parapet. Lime is wetted during this stage to ensure it doesn't set too quickly.

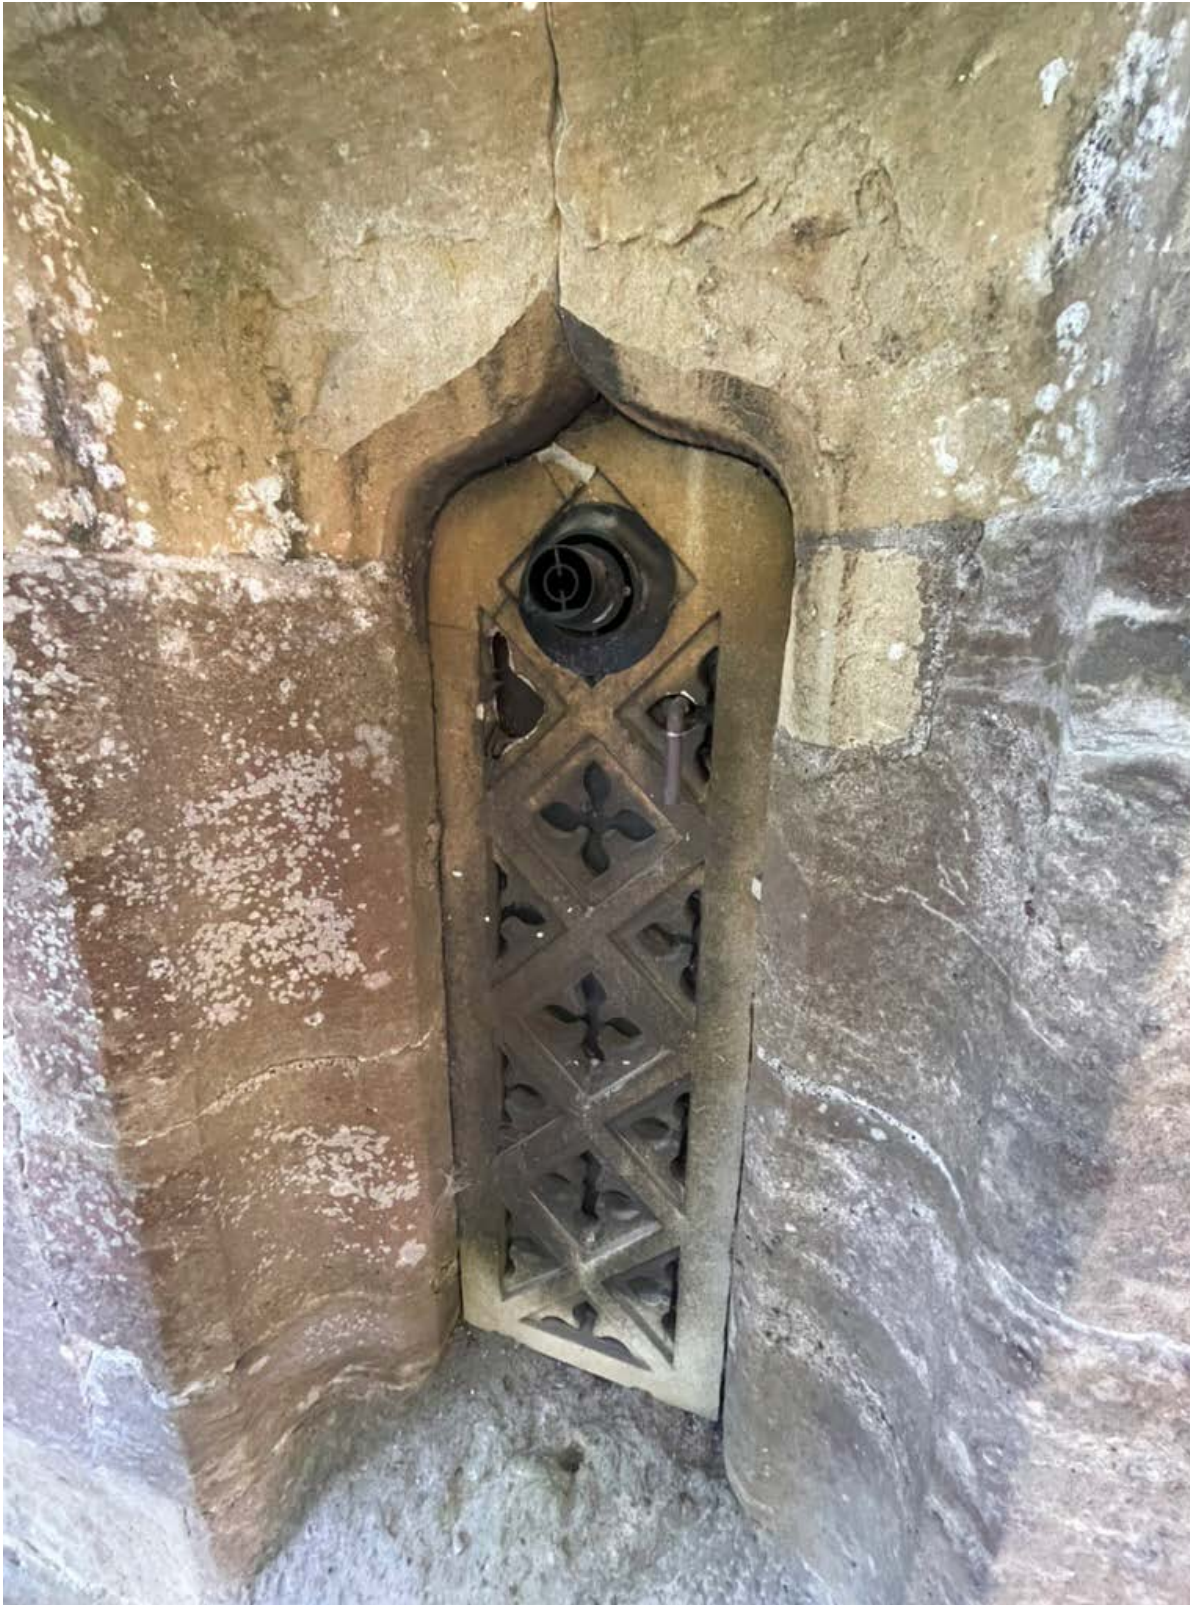
- 3.10. The north ringing chamber window has a flue protruding from the panel which is assumed to be active. The exhaust flue doesn't extend much away from the window aperture. It would be best for this to be extended. Amanda to discuss with the client team.

Image 6: Exhaust from the north elevation of the ringing chamber panel. Ideally would be extended.
